THEORY AND PRACTICAL EXPERIENCES IN PAVEMENT REHABILITATION USING ASPHALT REINFORCEMENT GRIDS

Fabiana Leite-Gembus¹, Daniel Hilpert¹, Marija Bakrac²

¹ Huesker Synthetic GmbH, Fabrikstr. 13-15, 48712 Gescher, Germany

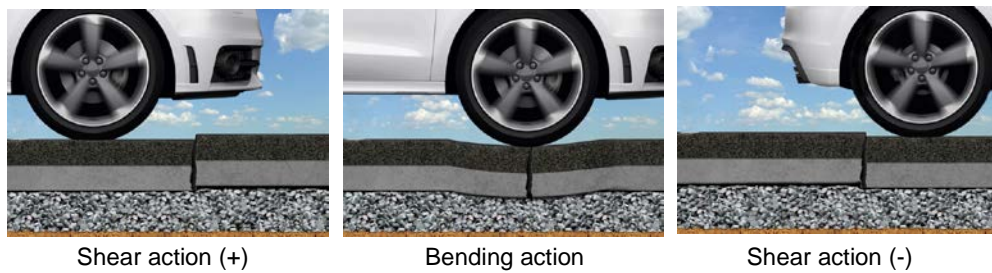
Figure 1. Critical loading cases in a pavement crack

When a wheel load passes over the road construction, localized bending and shear stresses appear on the existing crack and cause the origin and further development of cracks [1, 4]. The shear action occurs twice by each load application, while the bending action occurs only once (Figure 1).

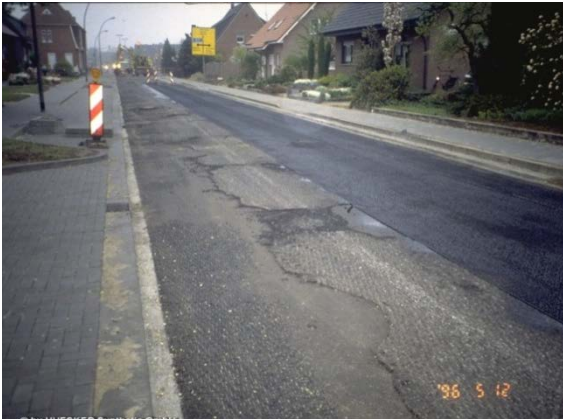
Figure 4. Condition after milling in May 1996

The municipal road Rosenstrasse is located in the northwest German town of Ochtrup and is a highly trafficked road. The majority of vehicles are trucks, because the road is one of the main connections to the nearby border of the Netherlands. In 1996, before rehabilitation, the road revealed severe alligator cracking, longitudinal and transverse cracking in large scale. The original design, and budget, called for milling the surface, approx. 50 mm, and installation of a new 50 mm asphalt surface course. Due to the problematic condition of the existing base the expected lifetime of the new surface was just 2 years (Figure 4).

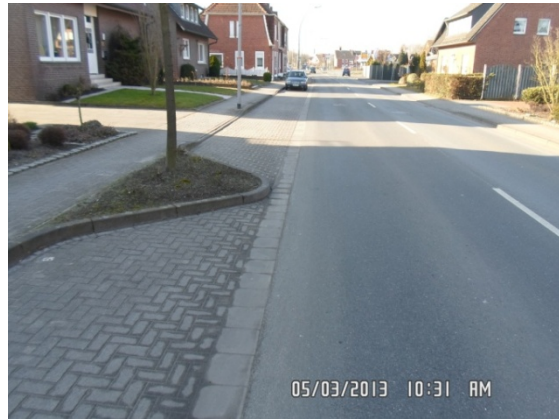
Figure 5. Condition in March 2013

To further investigate the condition, two drill cores have been taken. At one core, the interlayer bond according to Leutner had been checked. Between the asphalt bearing course - Polyester reinforcement - and upper asphalt layer a maximum shear force of 24 kN was measured. The German guideline for asphalt works – ZTV Asphalt-StB 07 – demands a minimum value of 12 kN, so this demand had been fulfilled. After evaluating the whole data record of the Rosenstrasse it was found, that the condition, after a lifetime of 17 years, was still very good (Figure 5).

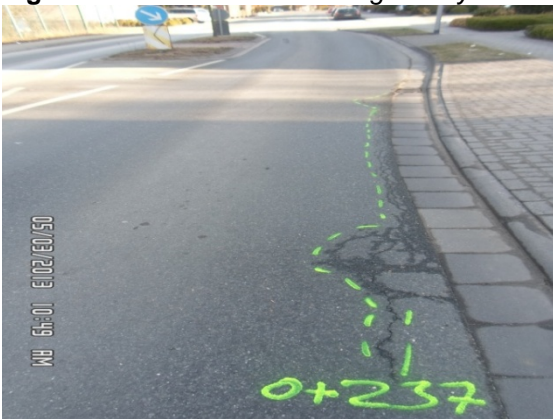
Figure 6. Cracking resulting from road works

In context of the visual assessment in 2013, cracks and settlements in the border area of the road and at some manholes and gullies have been identified (Figure 6). The cause of the cracking lies most likely in the fact that the compaction of underlying layers has not been properly carried out. The redensification of these areas by the traffic loads has led to the cracks at the road surface (Figure 7).

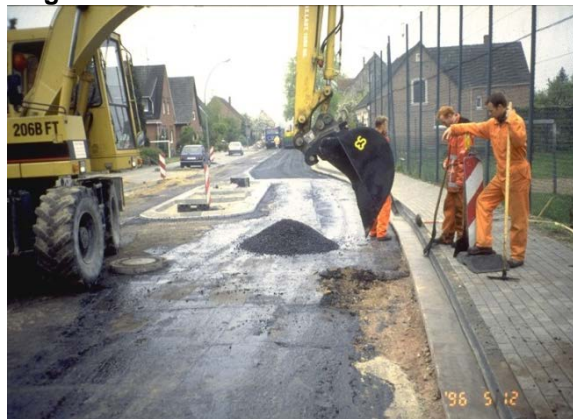
Figure 7. Repair works at the road edge in 1996

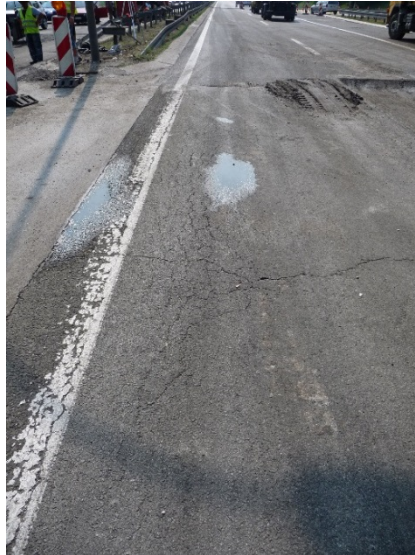
Figure 8. *Reflective cracking from cement stabilized base*

The dual carriageway E75 is one of the most important highways of Serbian road infrastructure. In 2010, the asphalt overlay of a section in Belgrade had become damaged by reflective cracking, likely caused by the cracking of the cement stabilized base (Figure 8). Cement stabilized layers provide excellent support for asphalt surfaces, however, it can lead to shrinkage cracks, which reflect through the asphalt surface.

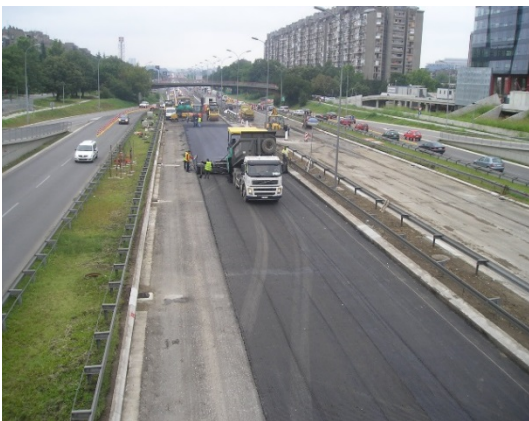
Figure 9. *Asphalt placement on HaTelit*

The existing pavement comprised of base, binder and wearing courses. The top two layers were removed to a depth of approximately 150 mm by milling. The milled surface was then brushed clean and a polymer modified emulsion was evenly sprayed onto the milled surface (in accordance with the manufacturer's installation guidelines). After the emulsion had been left to 'break' the installation of the polyester grid was carried out by unrolling the material over the emulsion and then rolling with a light tandem roller. After this the new asphalt layer could be placed directly onto the asphalt reinforcement grid (Figure 9). The road rehabilitation was carried out in July 2010.

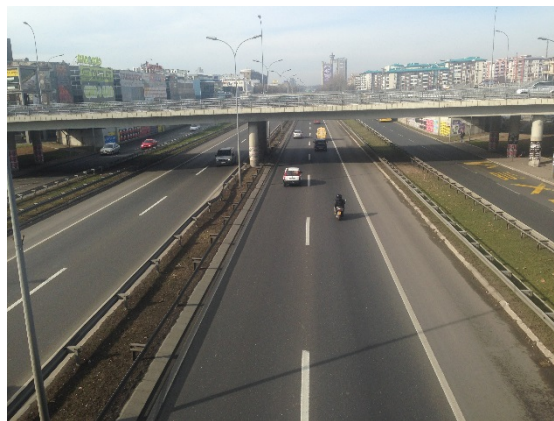
Figure 10. *E75 pavement condition in 2016*

Almost six years after the rehabilitation, the reinforced area in the highway E75 still does not show any indication of cracking (Figure 10). The use of a polyester grid prevented the propagation of reflective cracks developing from the cement stabilized base, proving to be an effective solution. The technique of introducing a polymeric reinforcement into bituminous pavements has been demonstrated to extend the working life of asphaltic pavements by up to three times. It is therefore anticipated that a similar benefit is expected to be achieved on this project. This will help to minimise any traffic diversions and disruption caused by this type of remedial work, as well as reducing future maintenance costs.
