GEOGRID-REINFORCED BRIDGE ABUTMENTS: REPORT ON A FULL SCALE TEST AND EXECUTED PROJECTS

The paper deals with the study of a geogrid-reinforced soil (GRS) solution for bridge abutments. A 4.5 m high geogrid reinforced vertical soil wall was directly loaded, near the top front edge, using a reinforced concrete block and hydraulic jacks, simulating the sill beam and load from the bridge. Loading and unloading cycles were performed, where the load was increased up to 3 times the normal load for this kind of structure. Settlements and horizontal facing deformations were measured during the test.

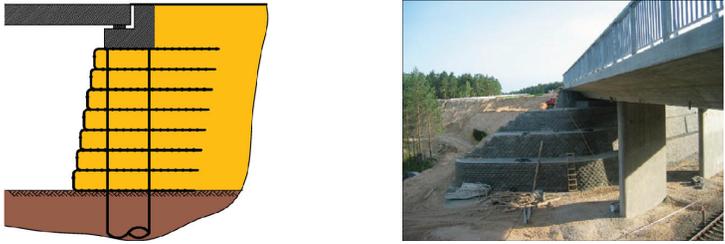
Figure 1. GRS as front and wing wall facing of bridge abutments (not loaded by the sill beam).

loaded by the sill beam, since the load from the sill beam is supported by separate conventional load-bearing systems such as reinforced concrete piles or similar (see Figure 1).

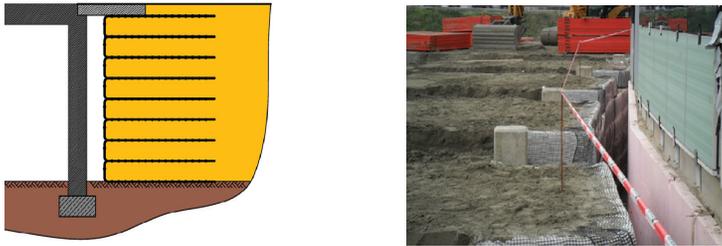
Figure 2. Geogrid-reinforced soil block behind walls as earth pressure relief.

It is also possible to relieve abutment walls and/or wing-walls of earth pressure by placing a GRS block at the back of them (see Figure 2). A 10 to 50 cm gap should be left between the GRS front and the back of the concrete wall, which can be either left open (unfilled) or filled with a very compressible material. The GRS only carries loads from the earth pressure of the backfill and traffic load.

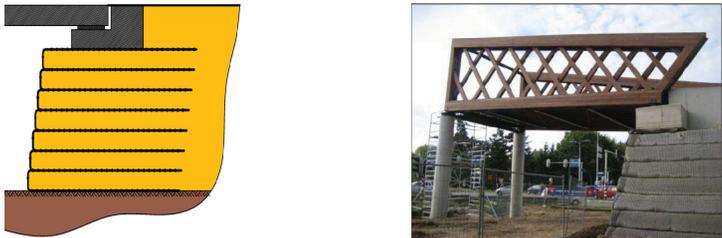
Figure 3. GRS as directly loaded bridge abutment.

The sill beam also can be placed directly on to the GRS abutment (see Figure 3). In this case the geogrid-reinforced soil body has to take the full load from the bridge and the sill beam.

The contact pressures are typical in the range of 150 to 250 kPa, which are transferred via the sill beam. The width of the sill beam is usually smaller than 2 m and located very close to the front of the bridge abutment. Compared to the normal applications of GRS walls and slopes this can be considered as a very concentrated high load at a critical location.

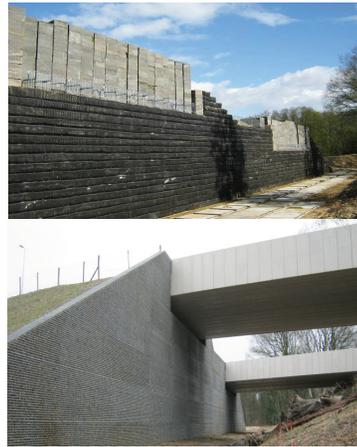
Figure 7. Measurement data of horizontal and vertical deformations during preloading and bridge deck installation as well as picture from the preloaded retaining wall and finished abutment with installed bridge deck (van Duijnen *et al.* [2]).

A new direct connection (A74) between the Dutch A73 and the German Bundesautobahn 61 (BAB 61) in the area of Venlo, the Netherlands was constructed. Part of the construction consists of two ‘ecoducts’ that guarantee the ecological connection between the north and south side of the road. The left abutment of the viaduct was constructed as geogrid reinforced retaining wall with a max. height of around 10 m. After finishing the retaining wall, but before installing the sill beam and the bridge deck, a preload is applied to activate the initial deformation of the retaining wall. After preloading and finishing the construction of the viaducts, the retaining wall is covered by the Muralex[®] facing system (gabion like facing) for protection and aesthetical reasons. The horizontal and vertical deformation of the wall were monitored by 26 markers until two months after installation of the bridge, see Figure 7.

The figures show that all vertical deformations are nearly in the same order, both in the top as in the bottom of both embankments. This means that the settlements below the retaining walls dominate. The vertical and horizontal deformations are within in the expected range.
